## Enhancing Infrastructure Resilience Through Emergency Bridge Reconstruction: Lessons from the 2023 Tsarevo Floods

Extreme rainfall events on 4–5 September 2023 caused severe flooding in the municipality of Tsarevo (Bulgaria), resulting in significant damage to local infrastructure, including the destruction of multiple bridge structures over the Cherna River. The event led to substantial material losses and human casualties, prompting the declaration of a partial state of emergency. The rapid increase in river and stream water levels caused extensive erosion of riverbanks, undermining reinforced-concrete abutments and piers, flooding urbanized areas, and depositing large quantities of debris, sediments, and vegetation within the riverbeds.

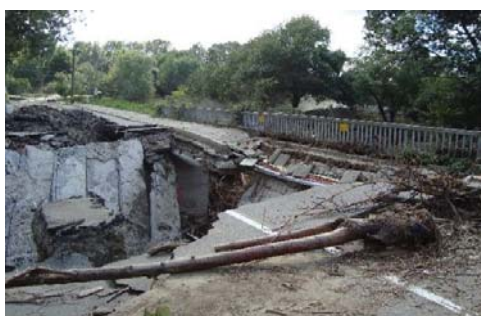
Fig. 3. Bridge – “White shore” – damages

At “White shore”, the damaged bridge had been a single-span reinforced-concrete structure with a clear opening of only about 5.0–6.0 m, carrying a roadway and two pedestrian sidewalks. The project assessment concluded that the structure had inadequate hydraulic capacity and could no longer serve as a safe support for the existing utility crossings. The hydraulic study further notes that the design flood passed with flooding of adjacent terrain and significant backwater, aggravated by the insufficient opening and by communication crossings located below the superstructure, which increased the risk of blockage by floating debris.

Third, the Tsarevo case confirms that utility crossings can be a critical hidden vulnerability. At “White Shore”, the reports state that the aerial sewer collector did not satisfy hydraulic-conveyance requirements and should be reconstructed as an underground siphon, because the insufficient clearance increased the likelihood of floating-body retention and partial blockage.

A sensitivity analysis with respect to the hydrological inputs, i.e. maximum design and control discharges, were performed as part of the design procedure. The latter indicates sufficient safety margins for the design flood discharges, especially if the bridge construction is followed by river training works to increase the channel capacity. It was concluded that a sufficient hydraulic performance is to be expected even with a 100% increase of the design discharge for the bridges at “Mandra” and “White shore” and even higher at “Coastal alley”. For “White Shore”, the final solution was a new single-span bridge with hydraulic clear width  $B = 17$  m; because of the adopted skew of 57 g, this corresponds to a clear opening of 21.78 m measured along the bridge axis. The structural solution uses six prestressed wide-flange girders type GT-95 with length 24.0 m, supporting a cast-in-place reinforced-concrete deck slab of minimum thickness 20 cm. The bridge carries a 6.0 m roadway and two 2.0 m sidewalks. The design also includes reinforced-concrete wing walls and bed lining for scour protection.

The hydraulic checks of the reconstructed solutions show substantial improvement. At “White Shore”, the project solution satisfies the required conveyance and freeboard criteria; under Q1% the backwater is minor, the minimum freeboard is about 1.4 m, the bearing seats retain about 1.1–1.2 m reserve, and the Q0.1% flood still passes without overtopping the structure.

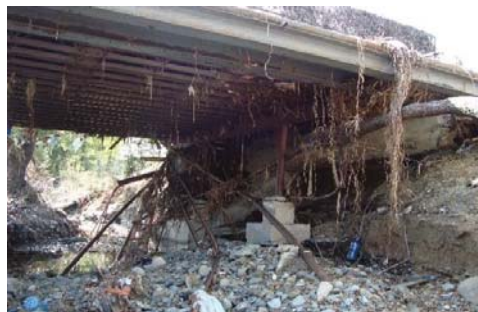
Fig. 4. Bridge – “Mandrata” – damages

At Mandrata, the pre-flood bridge was a single-span structure with a simple beam scheme and a composite concrete superstructure, with total superstructure length of 15.40 m and clear opening of about 14.0 m. It had no sidewalks and included suspended utilities. Despite its larger opening compared with “White Shore”, the structure was still judged to be fully destroyed and hydraulically insufficient under the required flood scenarios. The studies also identified a need for riverbed cleaning, removal of sediment islands, and construction of retaining and wing-wall elements.

For Mandra, the selected solution is also a fully new single-span bridge, but with a clear opening of 17.10 m and six prestressed GT-95 girders of length 19.0 m. The cross-section includes a 6.0 m carriageway and two 2.0 m sidewalks. The structural scheme eliminates the previous vulnerable arrangement and introduces reinforced-

concrete abutments, independent wing walls, and an overall geometry better aligned with the flow.

At Mandra, the Q1% water level at the inlet is 9.32 m, corresponding to about 1.35 m minimum freeboard and about 1.1 m reserve at the bearing seats. Under Q0.1%, the flow passes in weakly pressurised mode, but without overtopping the bridge. Average velocities in the opening at Q1% are about 1.63–1.73 m/s, increasing to 3.5–3.6 m/s outside the bridge and wing-wall zone, which confirms the need for riverbed and bank protection.

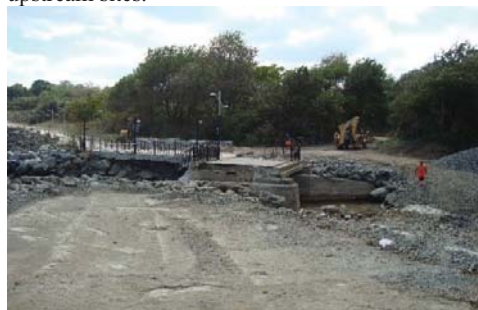
Fig. 5. Bridge – “Coastal Alley” – damages

At the Coastal Alley site, the situation was even more complex because the bridge is located at the river mouth, where river flooding interacts with marine conditions. The damaged bridge was a two-span reinforced-concrete structure with openings not exceeding about 5.0 m.

The hydrology report states that the Q1% flood overtopped adjacent terrain and the bridge approaches because of the inadequate opening and the low southern terrain. Owing to the river-mouth location, the hydraulic assessment also considered sea levels and wave-related effects, which adds an additional hazard component, not present at the upstream sites.

For the Coastal Alley bridge, the new configuration again adopts a single-span solution with a 17.10 m clear opening and six GT-95 girders of length 19.0 m. Because of local spatial constraints, the sidewalks are asymmetric, but the main resilience logic is the same: larger opening, simpler hydraulic behaviour, reinforced approaches, and dedicated protection against both fluvial and coastal effects. At this site, the project specifically prescribes rock-armour protection with characteristic parameters such as  $d_{50} = 750$  mm,  $d_{max} = 1200$  mm, minimum layer thickness 1.2 m, and slope 1:2, which is appropriate given the river-mouth and wave-exposed environment.

At the Coastal Alley, the Q1% backwater is minor, the minimum freeboard is about 0.76 m, and the bearing-seat reserve is about 0.46 m, both above the required minimums. The Q0.1% flood again passes without overtopping. Importantly, the comparison with the old configuration shows a significant reduction in upstream water levels under design flood conditions.

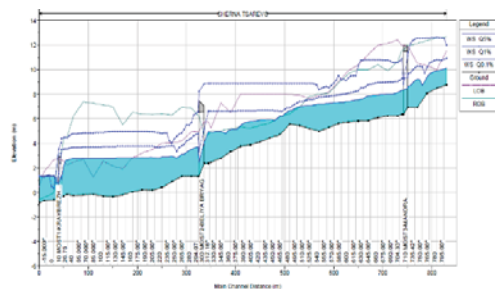
Fig. 6. Longitudinal profile with calculated lines of the free water surface in the research section of the Cherna

Coastal surge effects are accounted by using data for the maximum sea water levels (including wave set-up and run-up) at the coastal area of Tsarevo. This data originates from a national study, incorporated into the *National methodology for flood hazard and flood risk mapping in Bulgaria*. A downstream boundary condition, corresponding to a constant water level elevation was considered for all scenarios to assess the potential backwater effect of the sea water. The modelling results consistently showed that the existing configurations did not satisfy statutory requirements. At “White Shore”, the  $Q_{1\%}$  flood produced significant backwater and flooding of surrounding terrain due mainly to the inadequate bridge opening and downstream constriction. The existing utility crossing at the bridge inlet further increased the blockage risk. At Mandra, the existing arrangement was also hydraulically deficient, while at the Coastal Alley site the  $Q_{1\%}$  event overtopped neighbouring terrain and approach areas – Fig. 6.
