## Risk Assessment of Cultural Heritage Buildings using InSAR Monitoring

**Keywords:** InSAR, Finite Element Model, Ground Displacement, Structural Analysis, Risk Assessment, Small Baseline Subset, Persistent Scatterer Interferometry, Crack Widths, Damage States.

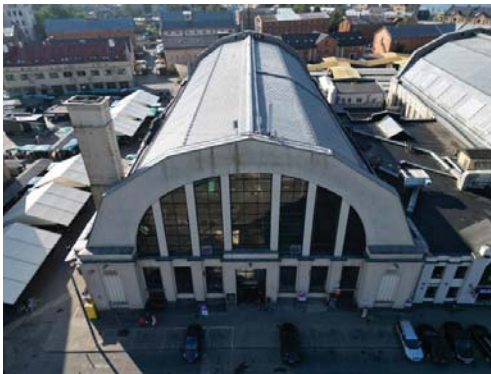
Fig. 1. Dairy Pavilion of the Riga Central Market (Māris Strazdiņš 2024)

Each pavilion hall is 20.5 meters high and 35 meters wide, with a basement built under the entire hangar area. The basement slab, supported by the foundation structure and a grid of masonry columns, is a cast reinforced concrete slab on steel beams. The load-bearing walls of the market pavilions were built of reinforced concrete and masonry (Bennett 2019).

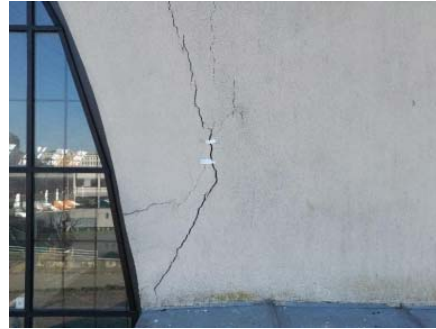
Fig. 2. Cracks in the North Face of the Dairy Pavilion (Māris Strazdiņš 2024)

damage to load-bearing columns, large wall cracking (Fig. 2), and noticeable tilting (Nikujins 2019). Moreover, a recent structural inspection report of the RCM revealed the presence of visible cracks in the North and South faces, raising concerns regarding its serviceability (as shown in Fig. 3) (Māris Strazdiņš 2024).
