## Proposed Test Method for Center Bound Risk Assessment: A Case Study

**Keywords:** Center bound, Prestressed concrete sleepers, Experimental test setup.

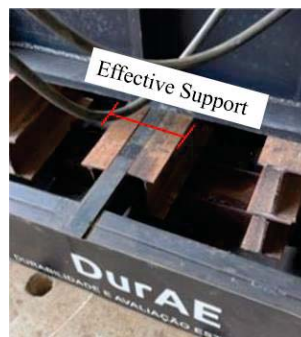
Fig.2. Steel box-type support device

The tests were carried out at the Structural Laboratory of the School of Civil Engineering of the Federal University of Uberlândia. A dedicated steel box-type support device was developed to reproduce the center-bound condition under controlled laboratory conditions. The support structure was built with a 3% downward slope from the center toward both ends, so that the sleeper remained effectively supported in the central region while support near the ends was relieved as Fig.2.
